US Army Corps of Engineers

**TECHNICAL REPORT GL-91-23**

# A STUDY OF EMBANKMENT PERFORMANCE DURING OVERTOPPING

Paul A. Gilbert, S. Paul Miller

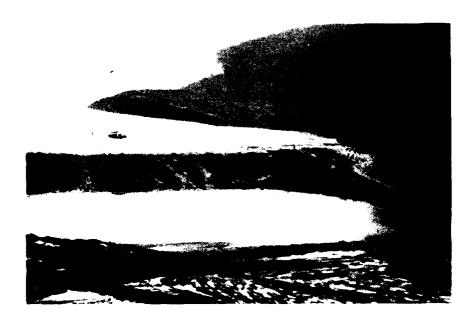
Figure 2. Notch area of Clarence Cannon cofferdam during initial overtopping

- 11. Overtopping data. Date 27-30 July 1981; maximum depth 5 ft, duration 3 days.
- 12. <u>Damage.</u> Overtopping flow was primarily contained in the notch area, with breaching in the center of the notch occurring after 20 hr of overtopping. Maximum depth (5 ft) was reached about this time. Limited flow over other areas of the cofferdam occurred for a few hours prior to notch breaching. The partially complete earth embankment, with very shallow slopes, allowed spread of the flow over a crest length of 850 ft. Apparently, the main embankment sustained very little damage until about 8 hr after notch breaching. At this time erosion reached the horizontal drainage blanket at the downstream main embankment toe and started removing the granular blanket

materials from beneath the central portion of the downstream slope. Undercutting of the overlying cohesive fill by removal of the drainage blanket continued for 8 or 10 hr until the chimney drain was reached. The chimney drain was removed from the left abutment to the concrete dam section without appreciable damage to the upstream portion of the main embankment. The chimney drain and 30 to 40 percent of the downstream embankment fill were lost.

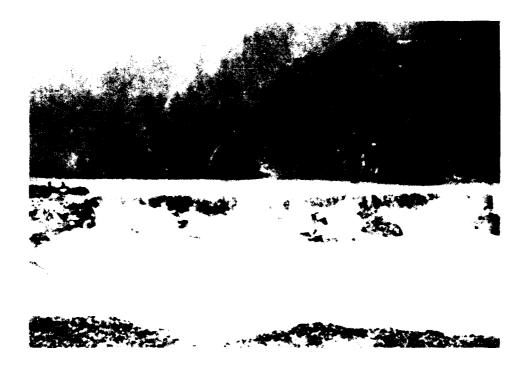
Figure 10. Berm erosion on downstream side of cellular cofferdam at R. D. Bailey Dam

- 22. The downstream berm of the diversion structure had been repaired to a 1V on 3H slope with a downstream toe of derrick stone (2- to 4-ft size), when a second overtopping occurred on 20 March 1975. This overtopping lasted for 15 hr, with a maximum depth of 2.5 ft, and caused erosion of the berm to the same level as the 14 March overtopping. Following this event, the berm

was restored to the 1V on 3H slope, with a splash pad at an elevation 15 ft below the structure crest. Twelve inches of concrete was placed over the berm with reinforced concrete on the splash pad. On 30 March 1974, a third overtopping, lasting 24 hr, with a maximum crest of 3 ft caused minimal damage to the berm area. The permanent cofferdam breach was left open during the 20 and 30 March events.

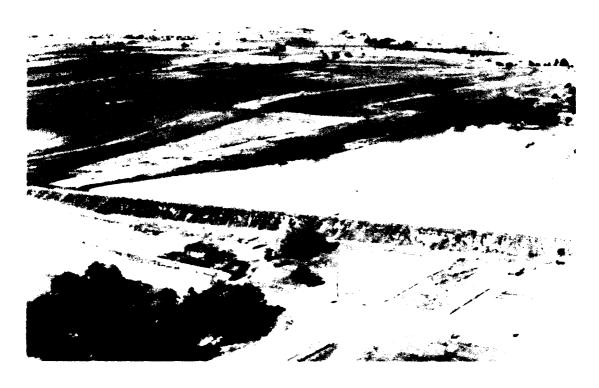
Figure 11. General view of Elm Fork Structure 9

- 25. Overtopping data. Date 12 October 1981; maximum depth 0.4 ft; duration ±3 hr.
- 26. <u>Damage.</u> Figure 11 is a general view of the damaged embankment; Figures 12a and 12b provide a closer view of the damaged downstream slope. The overtopping caused gullies or rills up to 5 ft in depth in the downstream slope. Apparently the overtopping lasted long enough to strip the vegetative topsoil and root structure from the compacted embankment layers along most of the embankment.

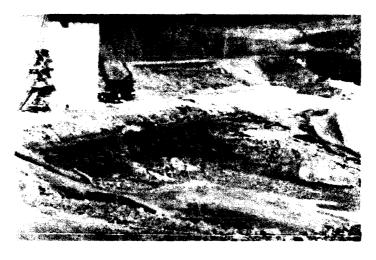
Figure 16. B. Everett Jordan cofferdam

- 50. Overtopping data. Date 3 February 1973; maximum height ± 1 ft; duration less than 24 hr.
- 51. <u>Damage</u>. Figure 16c, a general view of the construction site during overtopping, shows the partially complete inlet works and cofferdam. The cofferdam suffered a general erosion of the downstream slope with a sharp drop of the crest (Figures 16a and 16b). Because it served as a roadway, the upper center part of the crest was probably better compacted than the near surface soil on the downstream slope. Relief was provided by a crude spillway quickly cut in the left abutment seen at the right edge of Figures 16a and 16b and just at the left end of the cofferdam in Figure 16c.

a. View from right abutment

b. Overtopping damage

c. General view of overtopping

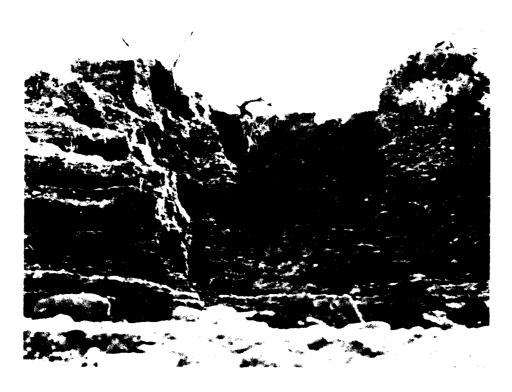
Figure 18. Damage to downstream slope of McCarty Dam

- 55. Apparently most, if not all, of the embankment was overtopped with breaching to the foundation occurring at the right abutment which was slightly lower than the rest of the embankment. The flow of water through the spillway probably produced a slope in the reservoir water surface from left to right (spillway to right abutment) along the crest, causing the greatest overtopping depth to occur at the right abutment. There is also some circumstantial evidence that seepage through the right limestone abutment may have aided breaching. Figures 18a and 18b are downstream views of embankment damage and reveal the chunkiness of embankment soil removal.

a. Slope erosion

b. Looking upstream into break at sta 7+57
